MINUTES

AD HOC COMMITTEE ON FAIRGROUNDS INFRASTRUCTURE

RE: Polk County Parks and Recreation
Structural Condition Evaluation of Existing
Grandstands - St. Croix Falls, Wisconsin
SEH No. POLKC - 138708 14.00

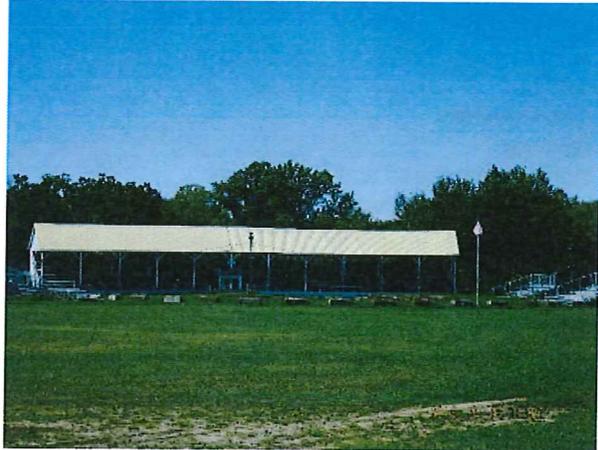
Photo 1: Grandstands from Front (East) Side

At the front and back of the grandstands structure, timber columns extend above the seating platform to a roof structure consisting of lumber trusses and roof joists. Columns extending to support the roof are typically 6x8 timber posts, although columns at each end are smaller and some have been previously repaired or replaced. Other posts not extending above the seating level range in size from 4x6 to 6x6 to built-up 2x6 columns. Some of the intermediate framing in the space below the bleachers (particularly on the north end) appears to have been a later addition. The framing below the seating platform is regularly braced with 2x lumber diagonal braces in each direction. Typical connections between braces and main frames were nailed. Main frame columns are connected to the front CMU wall with small diameter bolts and steel brackets. Some foundation connections have been previously repaired. The outside wall at the rear (west side) is framed with rough cut 2x6 studs at 24" on center between main frames. Original openings in the rear wall have typically been permanently closed and covered with metal siding on the outside of the building but a number of ventilation openings were maintained through the steel siding.

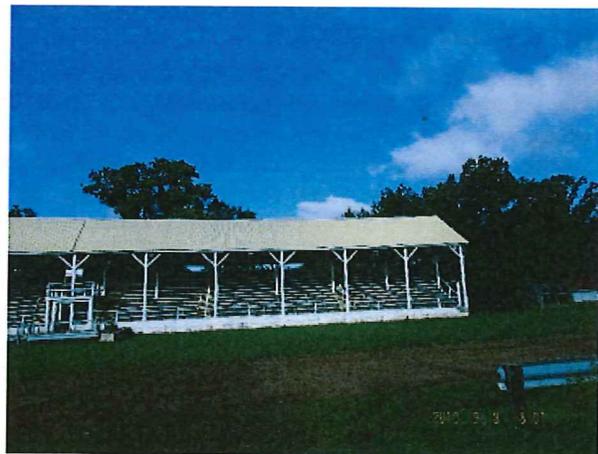
Photo 2: Note Sloped Seats Right of Knuckle

Settlement is most apparent at the north end of the building with the worst condition occurring about 30 feet from the knuckle. Settlement is visually evident viewing the front elevation of the grandstands (Photo 2). Other evidence is present within the area below the north wing including sloped braces that appear to have originally been horizontal, distress at the ceiling of the concession area (north part of the

knuckle), and the apparently unintended drop in the rear wall foundation north of the knuckle. Measurements of the footboard elevations using a contractor's self levelling laser showed a drop of over 16 inches from the middle of the knuckle to the second frame line to the north. The south wing also exhibits some settlement away from the knuckle, but only in the magnitude of approximately 2 inches. It is unknown to what degree the difference on the south wing is the result of soil movement as opposed to original construction tolerances. On the other hand, the condition of the north wing is a clear indicator of differential movement. While the settlement is readily apparent looking at the seats, the roof doesn't show nearly as much evidence of movement, suggesting some of the settlement

Repairs to address the settlement observed in this structure would be significant. Even assuming areas of moderate settlements of up to 4 inches would be allowed to remain, repair would require significant jacking, structure adjustment, and installation of supplemental foundation measures such as helical piles. If repairs are undertaken, it is likely that middle and rear columns would need to be jacked and supported throughout most of the north wing. Another option would be to leave the existing settlement in place on the north wing and provide foundation measures only to prevent further movement. This approach would also require repairing and reinforcing joints that have been damaged by the settlement and we would recommend repair or reconstruction of walls, ceilings, and other elements that have been damaged by the settlement. Considering the severity of the condition, the alternative of arresting but not correcting settlement may be preferable.

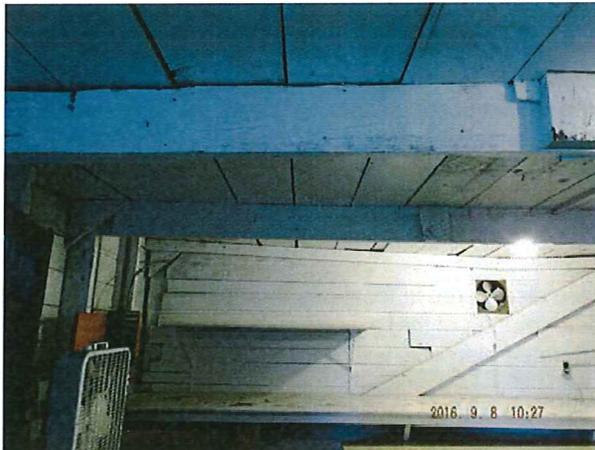
Photo 3: Uneven Ceiling and Sloped Beams in Concession Area

may have occurred immediately during construction. However, the lack of wood discoloration adjacent to a settled partition wall on the north edge of the concession area suggests that a large proportion of the settlement was not immediate.

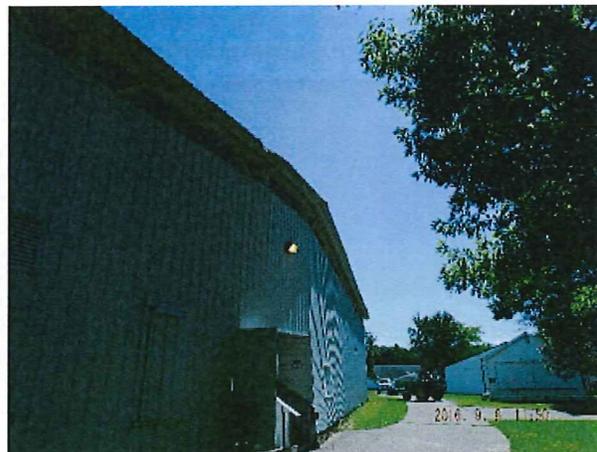
Photo 4: Visible "Twist" in Rear Wall at Knuckle

Lateral drift of the structure is also evident from a number of perspectives. Looking at the rear wall of the building, lateral drift of each wing is apparent. Measurements of plumb indicate that the middle columns of the south wing lean forward by generally 2 inches and as much as 4 inches in the first 8 feet above the grandstand seating elevation. The north wing middle columns lean the opposite direction, but less significantly. These columns lean back by as much as 2 inches in the first 8 feet above the grandstand seating elevation. The drift is most apparent when looking at the rear wall near the knuckle where the drift occurs in opposite directions each side (Photo 4).

Part of this lateral drift may be associated with the settlement of foundations (particularly on the north wing), but the magnitude and direction of movement on the south wing suggests that the drift may be permanent displacement from a past wind event. Such movement would likely stress or compromise bracing connections.

Repair of lateral drift conditions would require progressive operations to first apply force to adjust the structure to a relatively plumb condition then temporarily brace the structure until new supplemental connections could be established between existing braces, columns, and foundation anchors. The process may require cutting or removing nails at some existing connections before adjusting the building to avoid splitting or crushing the wood members at the connections. New supplemental connections would likely consist of a combination of bolts, nails, and off-the-shelf metal plate connectors designed for the purpose.

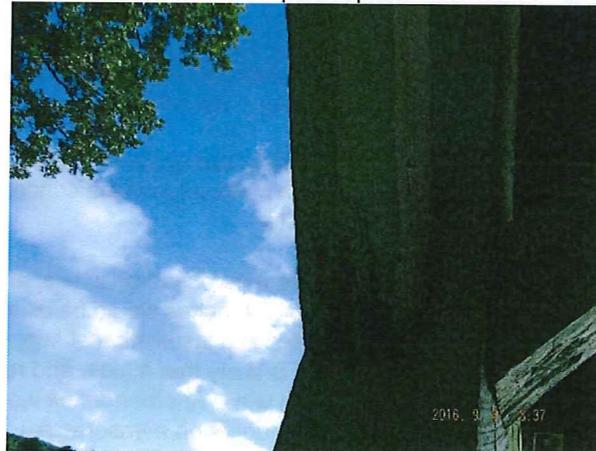
Photo 5: Deteriorated Knee Braces

A number of deteriorated existing wood elements were discovered in locations throughout the grandstand structure, primarily near exposed edges. Moisture deterioration of these wood members and connections results in reduced structural capacity, so these deteriorated elements will require repair. Deteriorated items observed during our site visit included:

- A small number of seat and foot boards near ends of grandstand
- Wood top rail of guards at both north and south ends
- 4x4 knee braces at main frame columns near end of building (Photo 5)
- Bases of main frame columns on front wall (particularly at press platform)
- Top of several 8x6 columns on west wall of north wing
- Roof rafters near ends of structure

Structural roof framing, column knee braces, and wood guardrail framing at each end of the grandstand exhibits severe to moderate deterioration within 10'-20' of the outside edge. Also several columns on the back face of the grandstands on the north end have been partially replaced, apparently because of prior deterioration. The capacity of seat and foot boards is compromised near the outside edges of the structure where the bearing and bending capacity are compromised by moisture-related deterioration. All of these deteriorated elements are considered unsafe conditions and require repair or replacement meeting the design criteria of the current code.

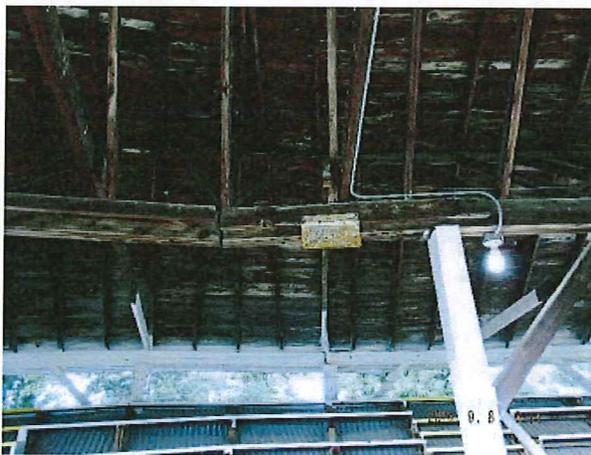
Photo 6: Excessive Roof Beam Cantilevers

Several conditions were noted where flaws in existing construction result in potentially unsafe conditions that should be addressed. These conditions include excessive cantilevers in roof beams where the north and south wings intersect at the knuckle (Photo 6). Another concern is the location of splices in roof rafters away from points of support. It is not clear whether these are original conditions or the result of later modifications, but supplemental framing should be provided to eliminate these weak points. The press platform also has a number of minor deficiencies including guard connections, middle beam sizing, and connections of beams to posts. These deficiencies can be corrected relatively easily.

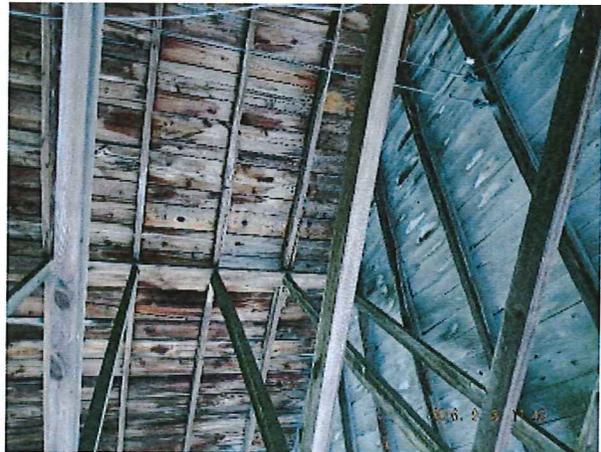
Photo 8: Deteriorated Roof Rafters and Deck Boards

Moisture deterioration in roof rafters, beams, and column knee braces results in significantly weakened connections at the perimeter of the building where wind uplift forces are highest (Photo 8). These compromised connections constitute an unsafe condition that necessitates strengthening of the deteriorated wood members and supplementing connections with engineered metal plate connectors.
